CENTURY MINE MITIGATION STREAM MITIGATION PHOTOGRAPHS
Long Run

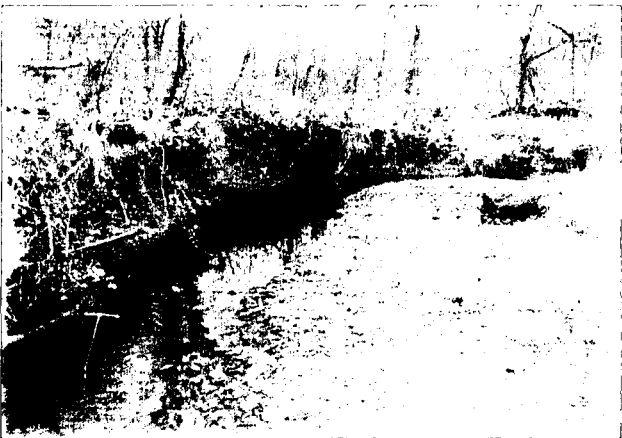
Photograph: 70
LRL-7: Unsuccessful stream bank restoration

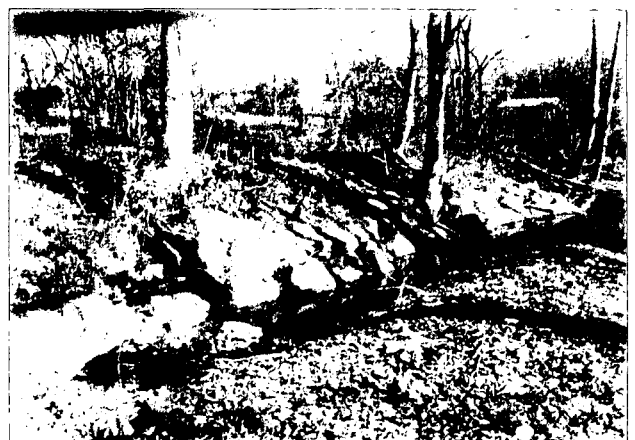
Photograph: 73
LRL-10: Successful boulder and toe protection
